**WALKIN THE WATERSHED - STREAM TEAM 2007**  
*Shoreline Survey Findings*

**Stream Segment:** MB-0

**Stream:** Middle Branch

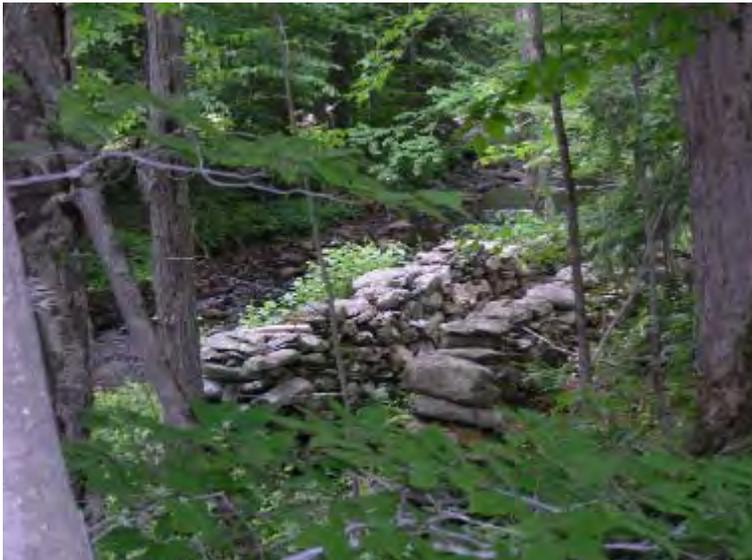
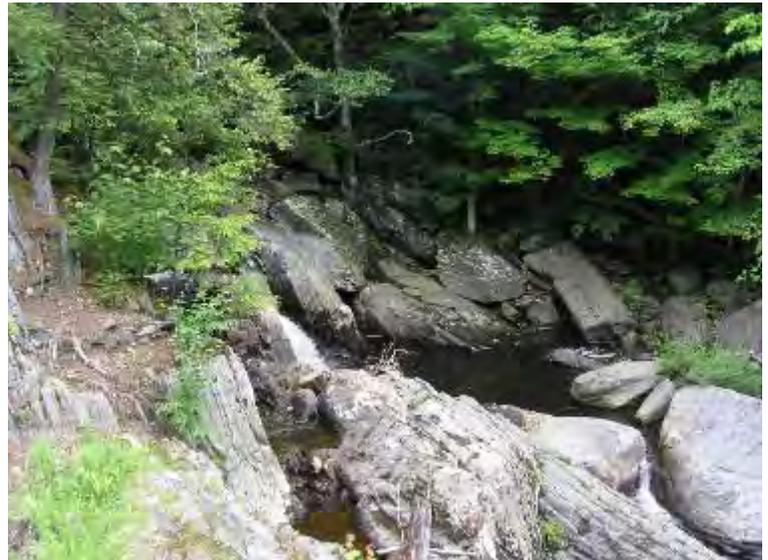
PROBLEMS:	ASSETS:	PROIRITIES FOR ACTION:
<p>1) We saw no signs of pollution or trash, degraded wetlands or invasive species. The only potential problem we found was the damming of a stream leading into the River, but it doesn't seem to have any material effect on the flow of the River.</p>	<p>1) This is an unspoiled segment of the Middle Branch of the Westfield River and should be maintained as such.</p>

At the beginning of Segment 1A just below the bridge on River Road, there is a significant drop-off and a waterfall (as well as a man-made pool). From the waterfall the River descends more rapidly down to a pool (approximately 1/4 mile below the bridge). For most of this segment, the River is not visible from River Road being well below the road level.

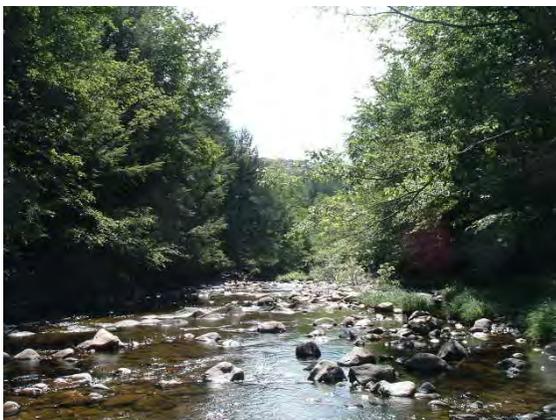
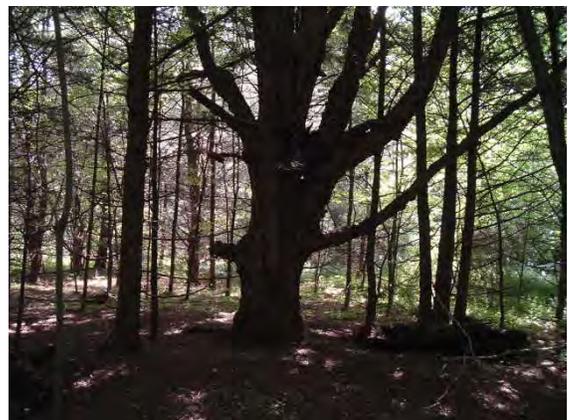
PROBLEMS:	ASSETS:	PROIRITIES FOR ACTION:
1) Runoff from East River Rd; 2) Bank erosion along East River Rd; 3) Japanese Knotweed	1) In general, landowners maintain very respectable filter strip. Landowners who take pride in maintaining proper filter strips along a significant resource areas are important assets. 2) Intact riparian zone, un-fragmented forest; 3) A "Legacy" Sycamore	1) Monitor land use changes 2) Monitor & eradicate Japanese Knotweed

Potential impacts to scenic and aesthetic values include scattered small populations of Japanese knotweed were observed and more than likely should be monitored or eradicated, if feasible.

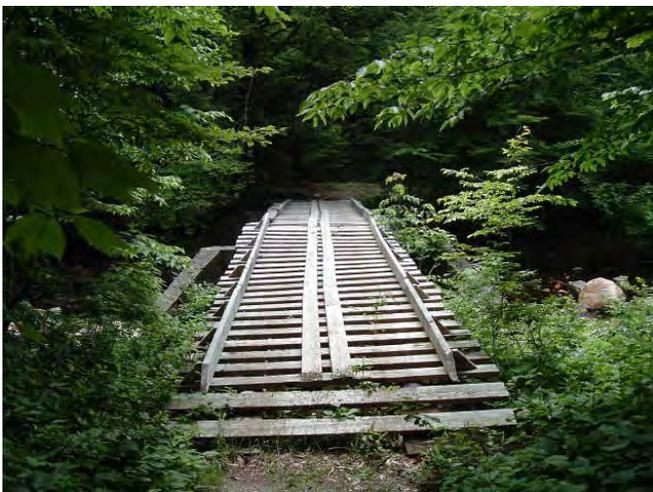
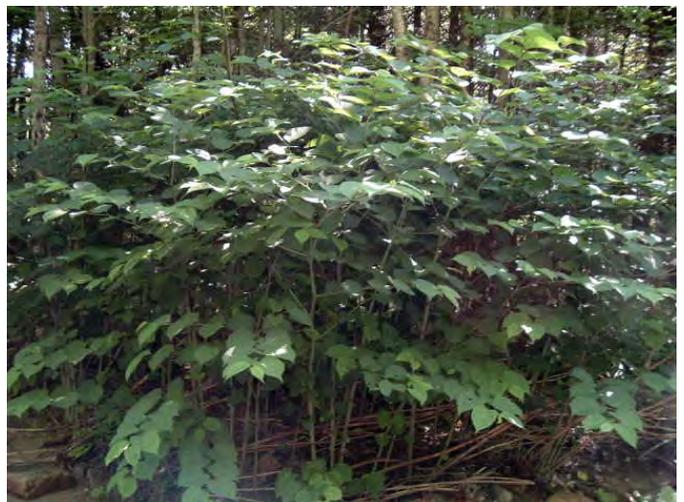
Public access can be gained at the snowmobile bridge. Lack of bridge maintenance or a storm event could be potential threats to the bridge.

A wetland community was observed at the end point of this segment. Habitat degradation is a potential threat.

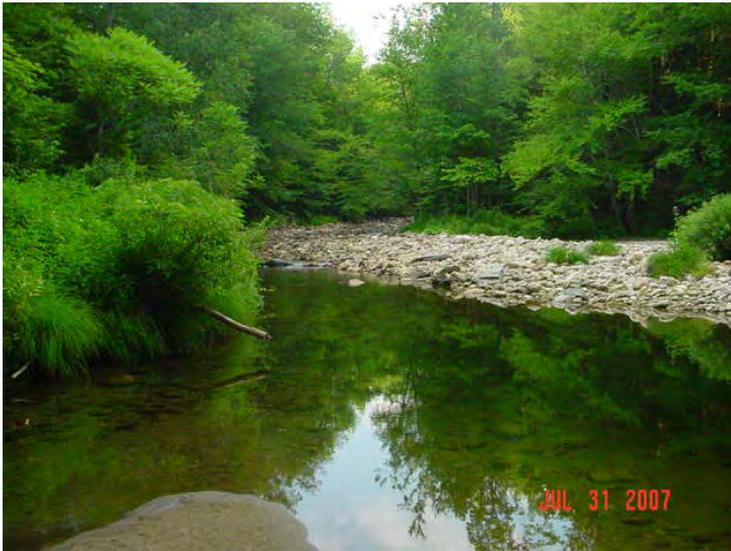
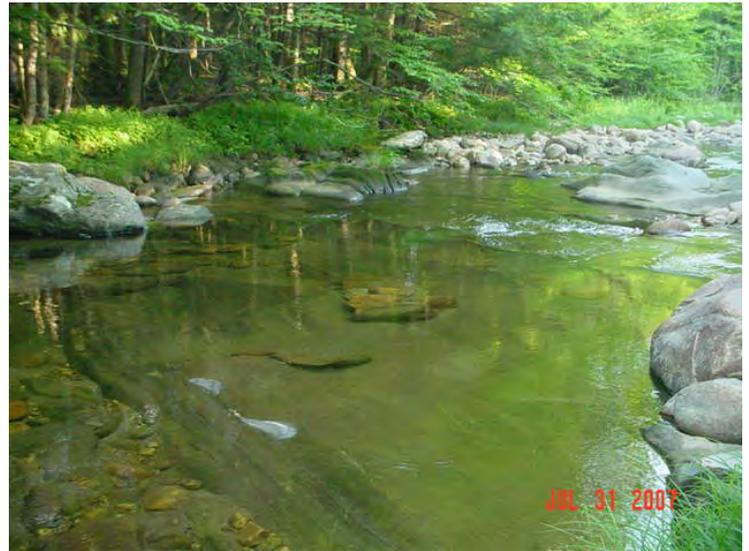
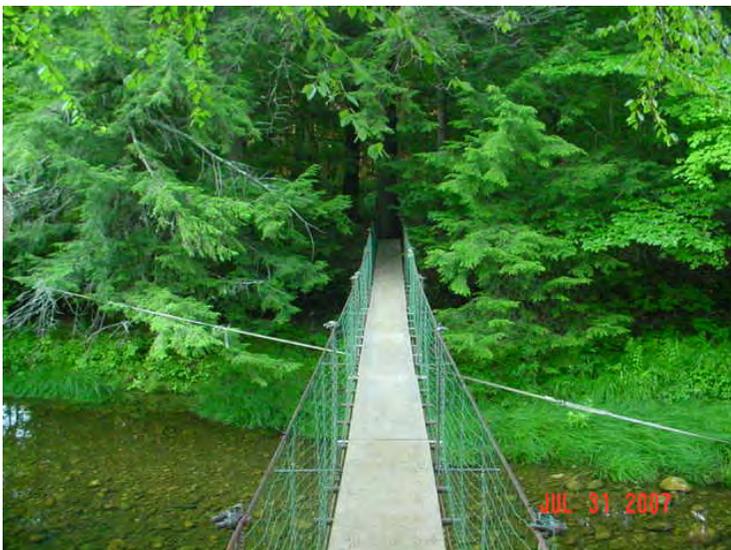
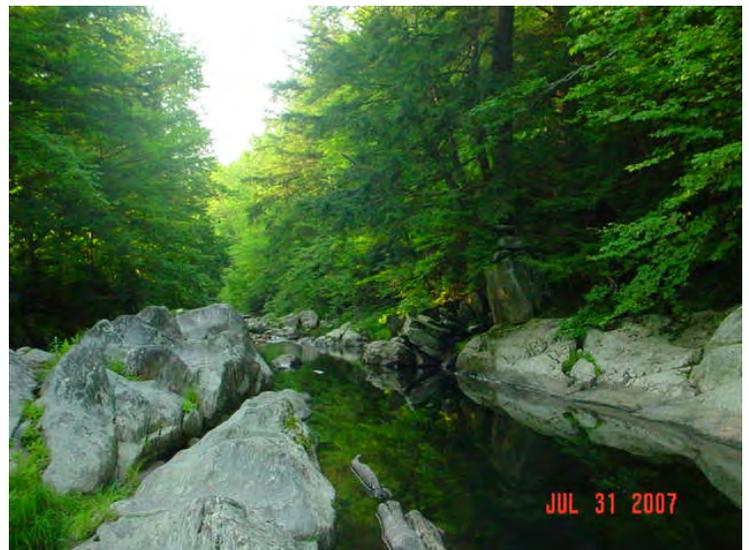
<b>PROBLEMS:</b>	<b>ASSETS:</b>	<b>PROIRITIES FOR ACTION:</b>
1) Japanese knotweed growing on bank at Clark Wright Road Intersection	1) Good habitat for fish, birds, mammals	1) Limit knotweed growth; 2) Limit cutting on bank along road

Despite running along a road and having a house on the bank in one section these segments appear to be in good shape. As long as the roadside vegetation is not cutback or the road is widened or re-aligned it should remain good. Hopefully the knotweed does not continue to spread north from Clark Wright Road.

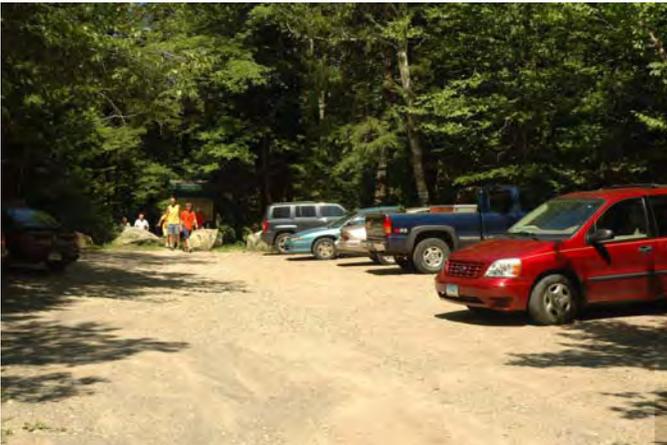
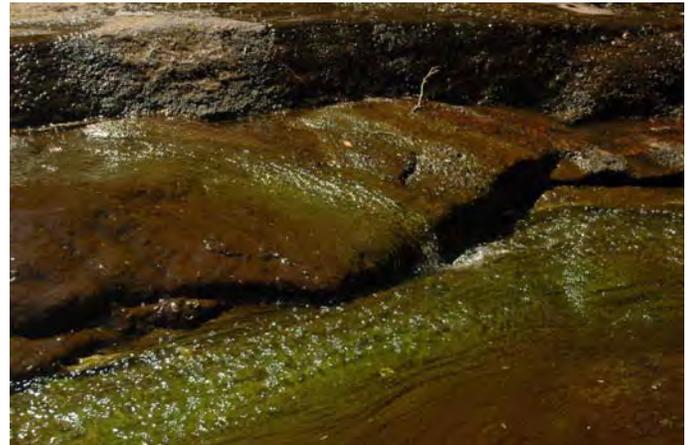
<b>PROBLEMS:</b>	<b>ASSETS:</b>	<b>PROIRITIES FOR ACTION:</b>
<ol style="list-style-type: none"><li>1) Run-off from parking lot</li><li>2) Slippery rocks creates hazard</li><li>3) Trampled vegetation, exposed tree roots and erosion</li></ol>	<ol style="list-style-type: none"><li>1) Scenic and recreational value</li><li>2) Little trash even with intense use</li></ol>	<ol style="list-style-type: none"><li>1) Divert run-off from parking lot away from river</li><li>2) Hazard warning sign</li><li>3) Clearly mark designated trail and let other areas recover</li></ol>

I have two concerns regarding the recreational use of the Falls. The footing is quite tricky as one passes over the rocks. It would not be hard to fall, slide, or twist an ankle. It is clearly a "enjoy at your own risk" situation, but a sign or some type of warning might be wise. The rock can be surprisingly slippery when it gets wet as well. My second concern has to do with the path along the stream leading down to the pool. If there is a designated trail, it is very poorly marked. This has led to multiple parallel trails along the south edge of the falls. Foliage has been trampled, and the roots of trees have been exposed, creating both treacherous footing and hastened erosion. I would like to see a clearly marked trail leading down through the woods, allowing the other paths to recover.

A final issue that might bear further review concerns the small dirt parking lot-pull-off at the head of the Falls (Note: Sunday we surveyed there were 11 cars in the lot). The lot slopes in the same direction as the river, and one can easily follow the run-off channels as they leave the parking lot and join the stream 15 yards downhill. Of course, in any heavy rainfall event, any contaminants from the parked cars (dripping oil, radiator fluid, and picnic trash) would inevitably end up in the river. I think this might be remedied by the installation of a runoff ditch at the base of the parking lot, diverting rain runoff away from the river.
