**WALKIN THE WATERSHED - STREAM TEAM 2007**  
*Shoreline Survey Findings*

**Stream Segment:** MB-0

**Stream:** Middle Branch

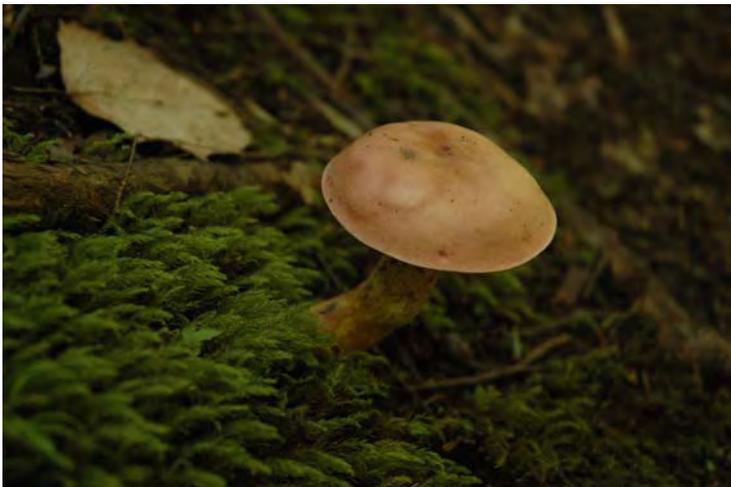
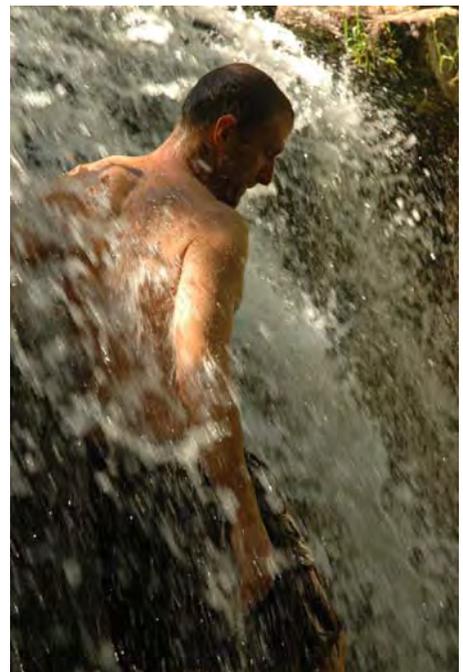
The Trustees of Reservations website notes that "The surrounding forest includes hemlock, birch, and beech with an understory of maple, hornbeam, witch hazel, shadbush, and mountain laurel." The overgrowth of hemlock as a climax species is very much in evidence. The mountain laurel provides a refreshing diversion from what I experience as the dreariness of the hemlock forest. We found a number of interesting fungi on our hike through the understory. While we did not encounter much wildlife, I am sure the surrounding woods are full of deer, wild turkeys, salamanders, and other local inhabitants of our Hilltown natural climes.
